# Lessons Learned From the Failure of Geotextile Erosion Control Tubes

by G.N. Richardson

**ABSTRACT:** Large circumference sand fill geotextile tubes were used to stabilize the beach on a small private island facing the Atlantic. The tubes were stacked to provide a low profile erosion resistant barrier to shoreline erosion. The geotextile tubes were used in place of concrete or sheet pile revetments because of a State law that limited the use of 'hardened' structures on the coastline. This paper reviews two design concepts for the tube erosion barrier system and chronicles the installation of a regulatory driven compromise system. Additionally, the paper describes the eventual failure of the regulatory system and makes observations regarding the performance of such systems.

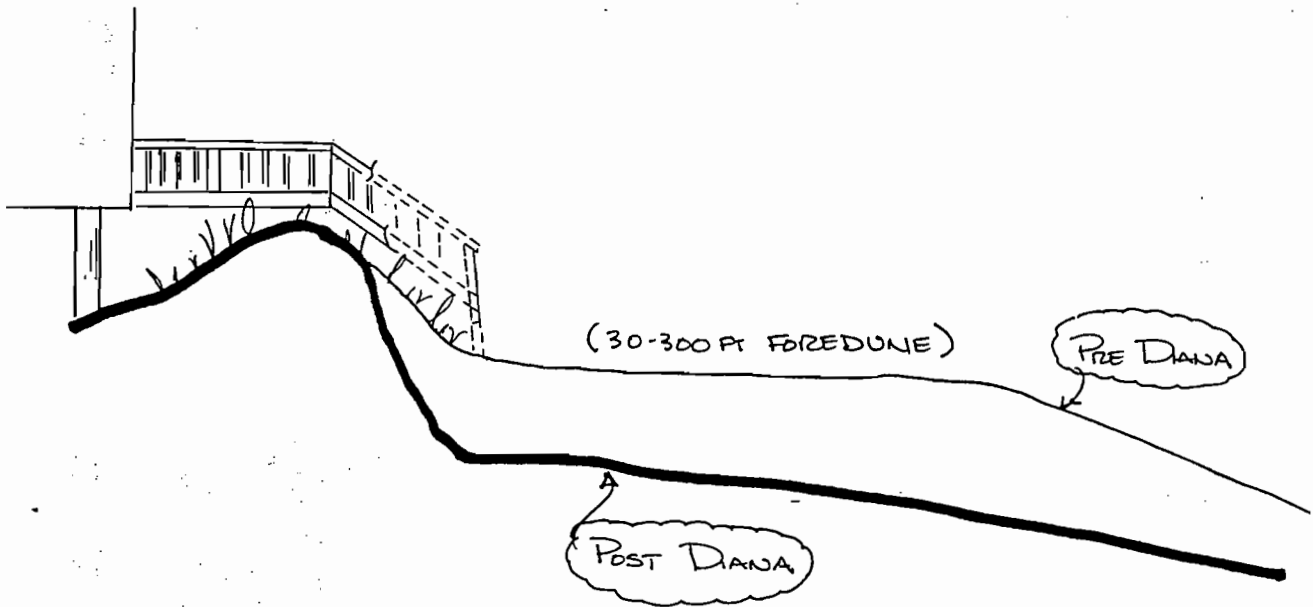
Figure 1 Shoreline Depletion from Hurricane Diane

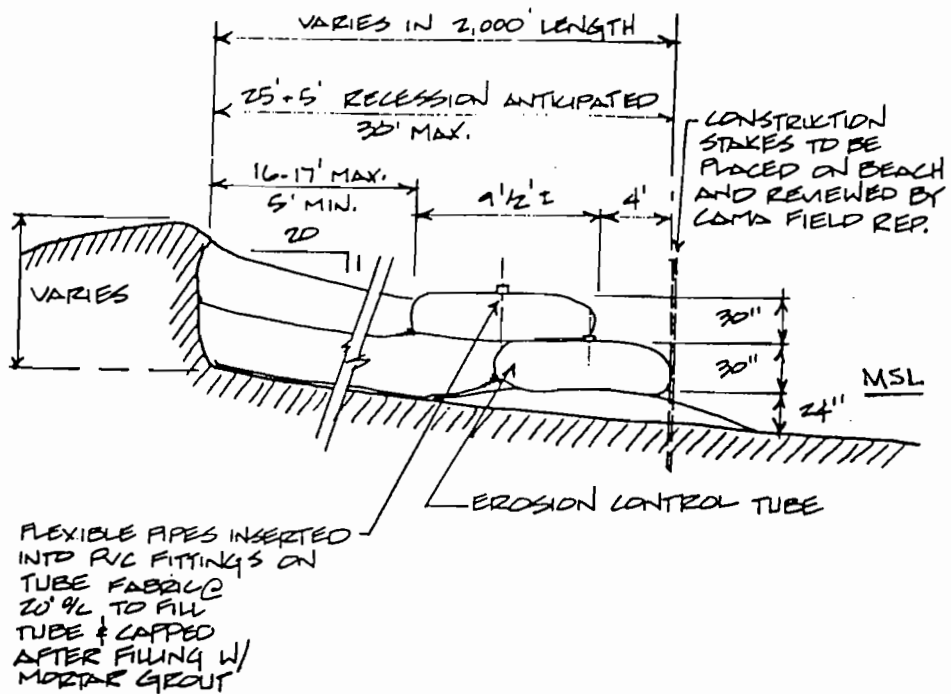
A section drawing of the proposed soft shoreline erosion control system is shown on Figure 2. Each erosion control tube was to be constructed of a 16 ounce per square yard polyester nonwoven geotextile. The tubes were to be sewn together using two lines of stitching forming a prayer seam. The AOS of the geotextile was selected to provide maximum retention of the sand filling while still allowing rapid drainage of water. Individual tube lengths exceeded 400 feet and the overall length of shoreline to be stabilized was approximately 2000 feet, see Figure 3. It was assumed that the tubes would be filled by inserting the discharge pipe from a small cutter head dredge reclaiming sand from offshore sandbars.

Figure 2 Section of proposed Shoreline Erosion Control System

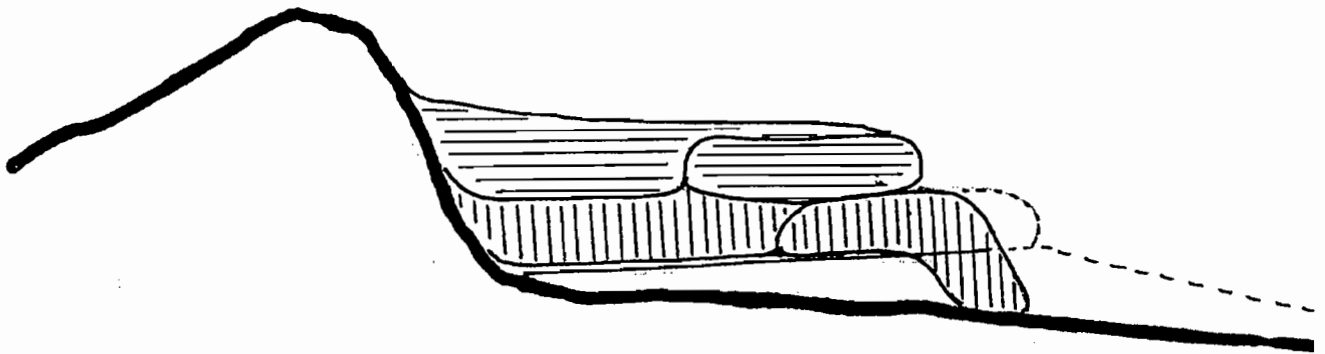
The geotextile tubes were intended to limit erosion by shielding the sand located behind the tubes from the force of the surf. As the sea removed sand from the toe of the system, the lead tube would drop and prevent the sea from undercutting the tube grouping as shown on Figure 4. Past studies had shown that the sand was commonly removed to a depth slightly below the -3 feet mean sea level (MSL) level. The design called for placement of the first (and lowest) erosion control tube at an elevation close to this elevation. This would limit the potential depth that the tube would have to drop to seal off further sand loss. It was anticipated that the sand loss would occur during a winter Northeaster or during a fall hurricane. That following spring, it was common for the sand from off-shore sandbars to be redeposited on the shoreline. This natural replenishment had previously been insufficient to restore the beach but would be sufficient to bury the erosion tube system before the summer season.

Figure 4 Sealing Role of Lead Tube

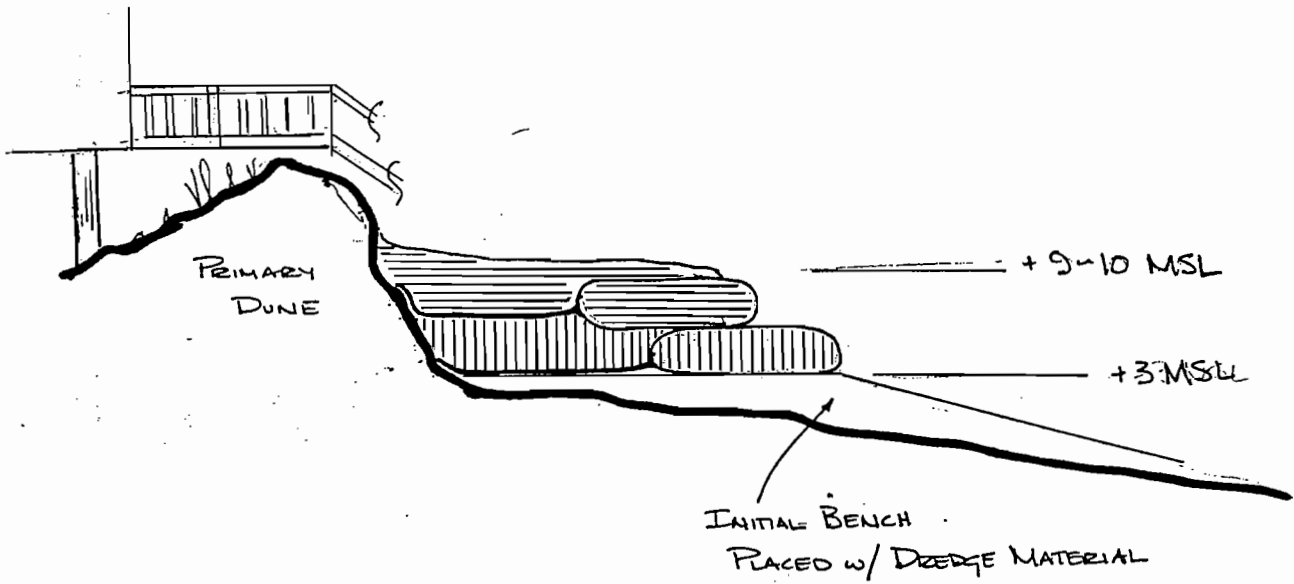
At this point the author was asked to review the design of the shoreline erosion control system to evaluate the impact of the CAMA ruling. The raising the system of erosion control tubes meant that more than 6 feet of sand could be removed from the toe of the system. This would result in significant stretching of the lead tube as in deformed to limit soil loss from beneath the tube system. This distortion could cause failure of the lead tube either by bursting of the tube or by the tube simply rolling into the sea. It was clear that the nonwoven geotextile would not have sufficient strength to remain intact after significant movement. At this point, the author recommended abandonment of the project.

Figure 5 Section of CAMA Approved Erosion Control System

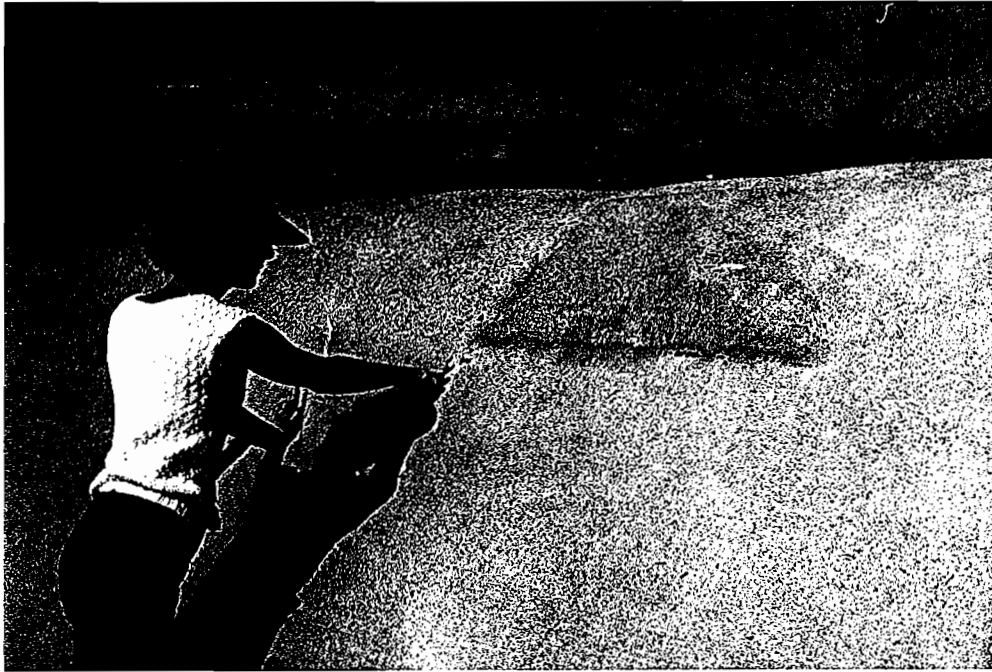
After approximately two months of service, the erosion control tubes began showing signs of localized failure of the geotextile. These failures were due to damage of the tubes by fisherman stabbing pole holders through the bags and other points of weakness in the nonwoven geotextile Figure 8, and at the locations of the dredge pipe fill ports, Figure 9. The fill port failure was particularly surprising and occurred when a Lyster gun had been used to thermally seam a flap of geotextile inside the tube. These breaches in the tubes were simply repaired by sewing patches over the holes and signs were placed on the beach to remind beach users to use care around the tubes. Fortunately, since the island is private, all beach users had a financial stake in the tubes and the frequency of damage reduced.

Figure 9 Micro-Degradation of Tubes - Dredge Pipe Fill Ports

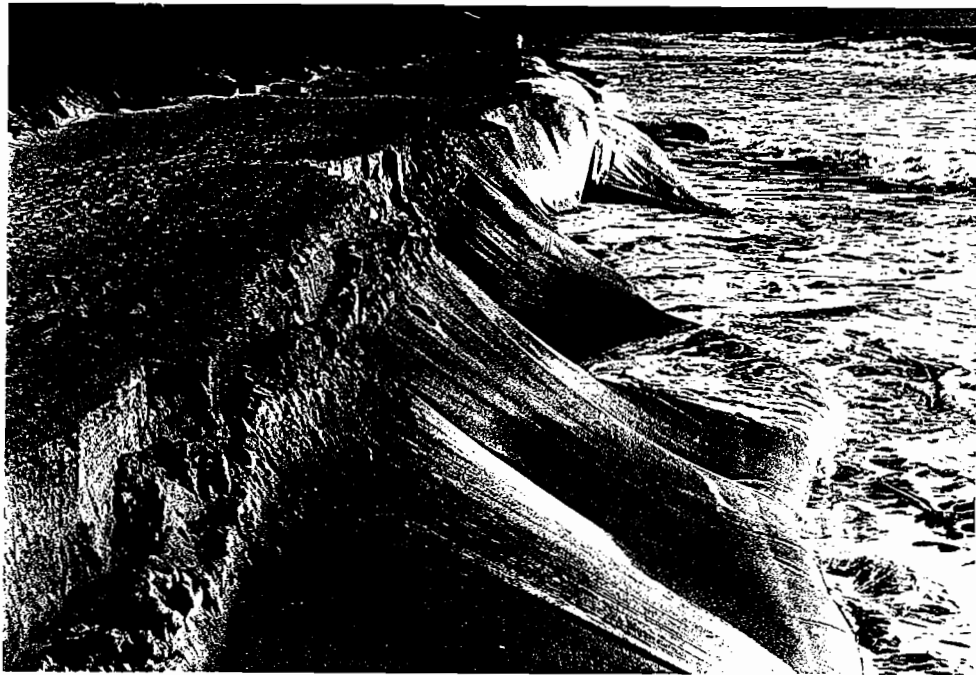
Early in winter, a large Northeaster struck the North Carolina coast and precipitated dramatic erosion seaward of the tubes. This erosion caused the lead tubes to drop dramatically; in some locations the drop exceeded 10 feet. The lead bags initially stretched and managed to maintain the erosion seal. This gave the impression of a curtain of geotextile forming a low retaining wall, Figure 10. Within days, several of the tubes had rolled from the system into the sea and gave the appearance of dead whales floundering on the shore, Figure 11.

Figure 10 Macro-Failure - Excessive Drop of Lead Tube
