LESSONS LEARNED FROM THE FAILURE OF A GEOTEXTILE REINFORCED RETAINING WALL FACING

by G.N. Richardson

KEYWORDS: Geotextile, Retaining Wall, Failure, Wall Facing, Field Observations

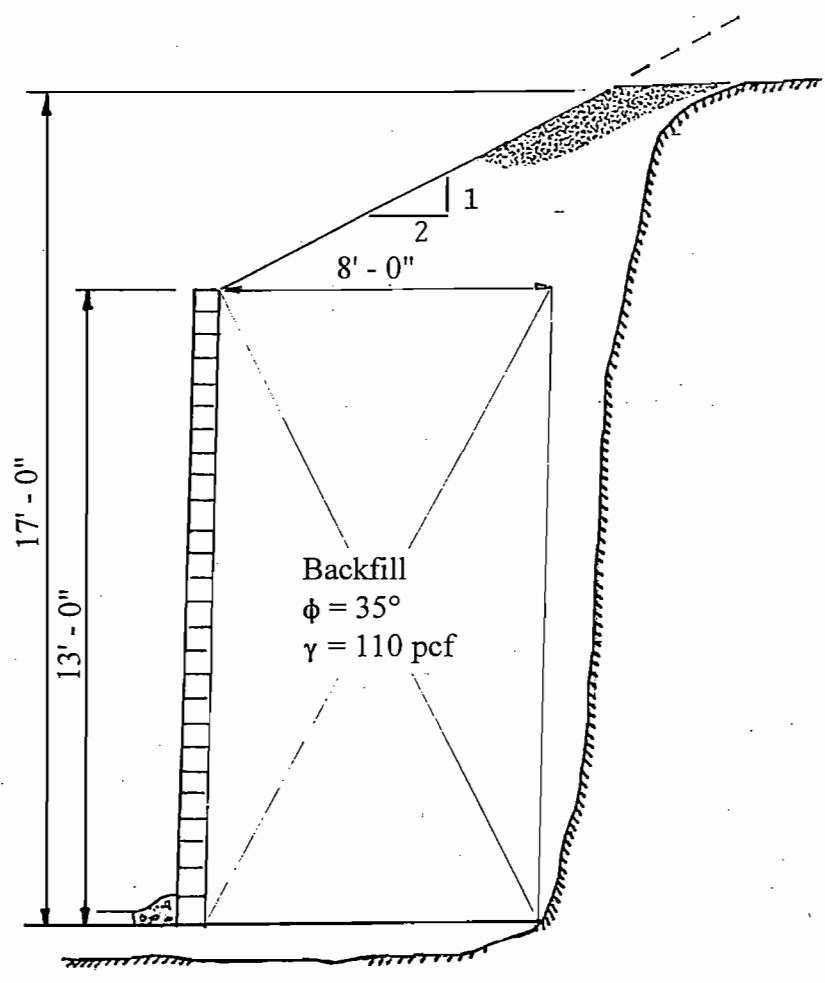
Figure 1 Maximum Design Wall Section

In the fall of 1987, Soil & Material Engineers was providing general geotechnical services for the construction of a small retail center being constructed in Raleigh, North Carolina. It had become obvious during the planning of this center that vehicle access to the rear of the center would be very limited. To ease access, the Raleigh office of Soil & Material Engineers was asked to design a retaining wall for the northern property line. The required wall would have a maximum height of 13 feet and a length exceeding 340 feet. The restricted space at the site limited the depth of the reinforced zone to less than 8 feet. This resulted in a wall aspect ratio (reinforcement length/wall height) of 0.60. The details of the wall geometry at maximum height are shown on Figure 1.
