IN-TRACK PERFORMANCE OF GEOTEXTILES
AT CALDWELL, TEXAS

Paper for Presentation to

Transportation Research Board Conference
Washington, D.C., January 1986

ABSTRACT

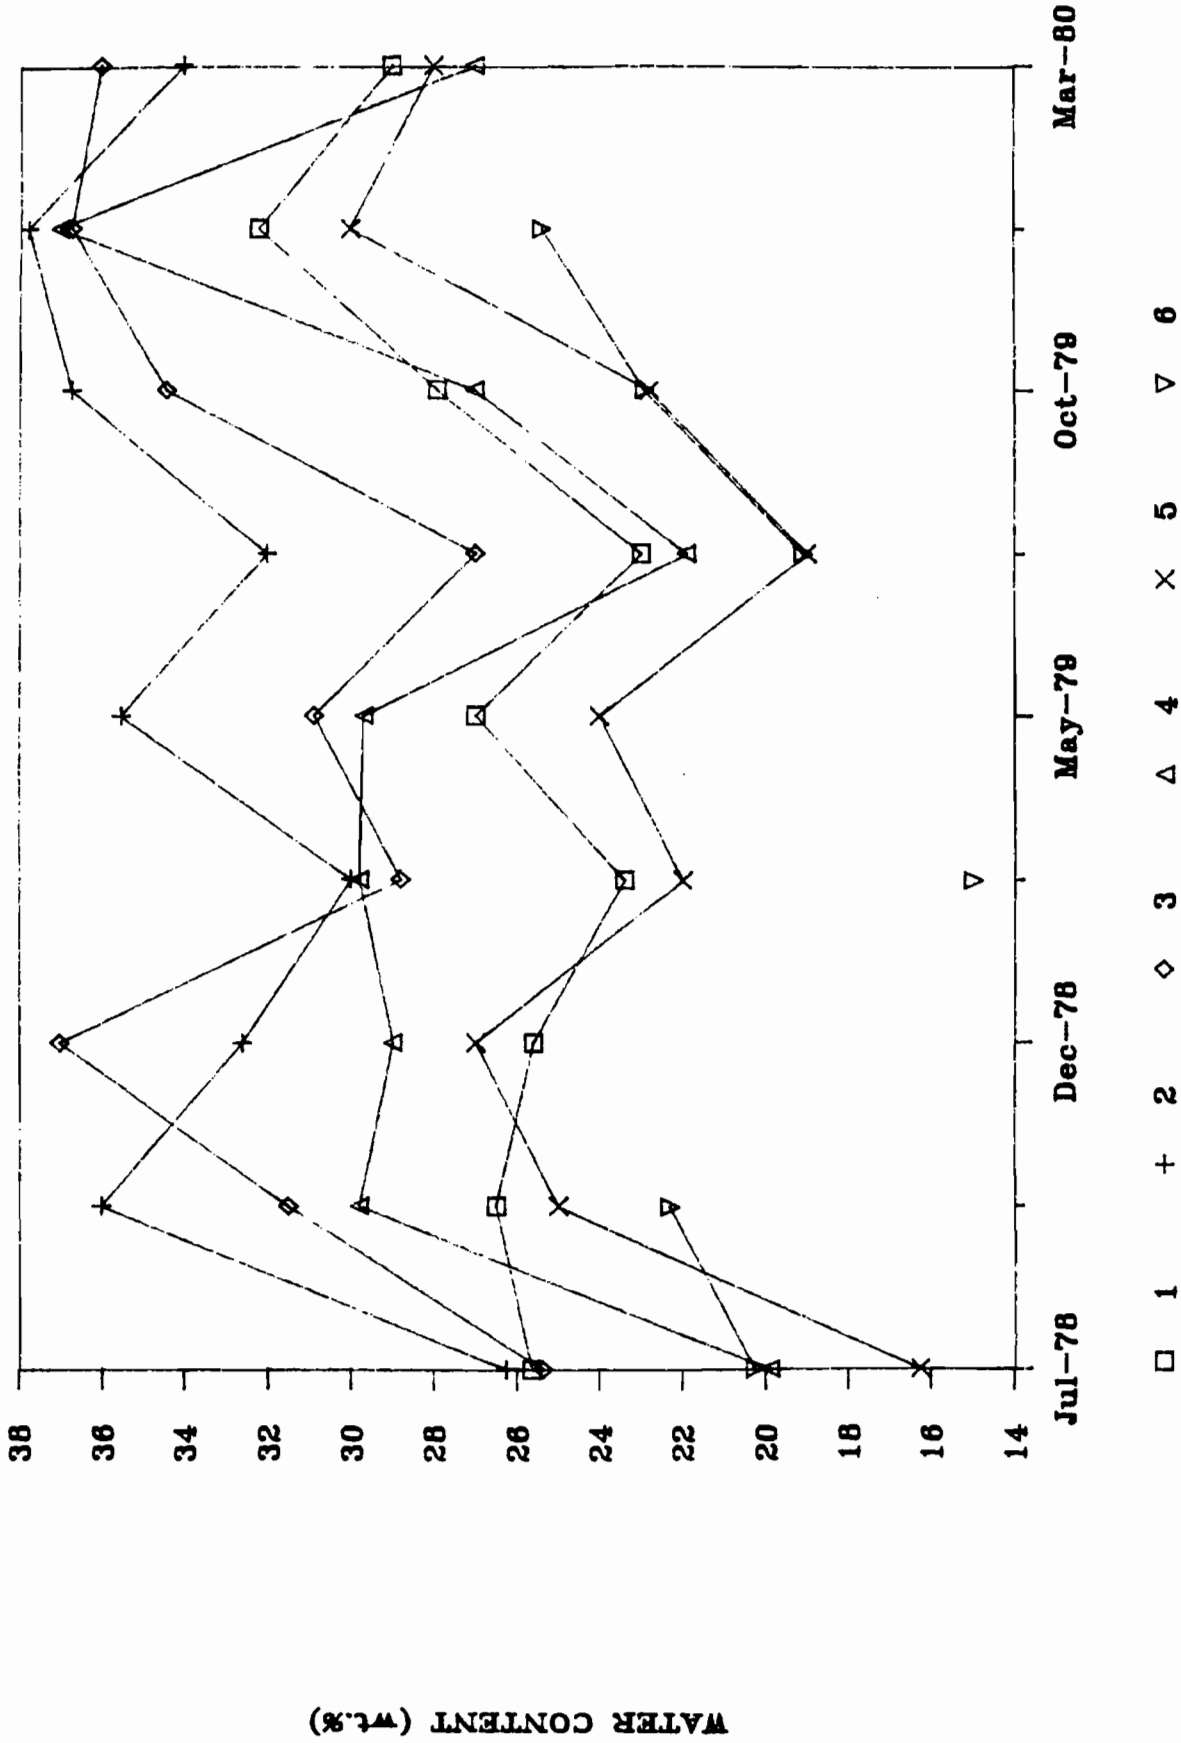
Figure 3. Variations in Average Soil Water Content With Time, in Test Sections 1 - 6

those using instrumentation, gave values of moisture content that were close to those of the field corings. However, the instrumentation responses were more "flat" and did not show the increase due to the rainy months of March through June as did the samples recovered from the field. Because the water content measurements from the manual corings are believed to be the most reliable, only the data from the field corings will be shown. Soil samples were obtained every 6 inches, to a depth of 24 inches, at the middle of each test section. Figure 3 illustrates the variation of subgrade water content in the test sections over approximately one and one-half years. Figure 4 shows the test section differences between the seasonal maximum and minimum soil moistures which occurred during the 17 months.

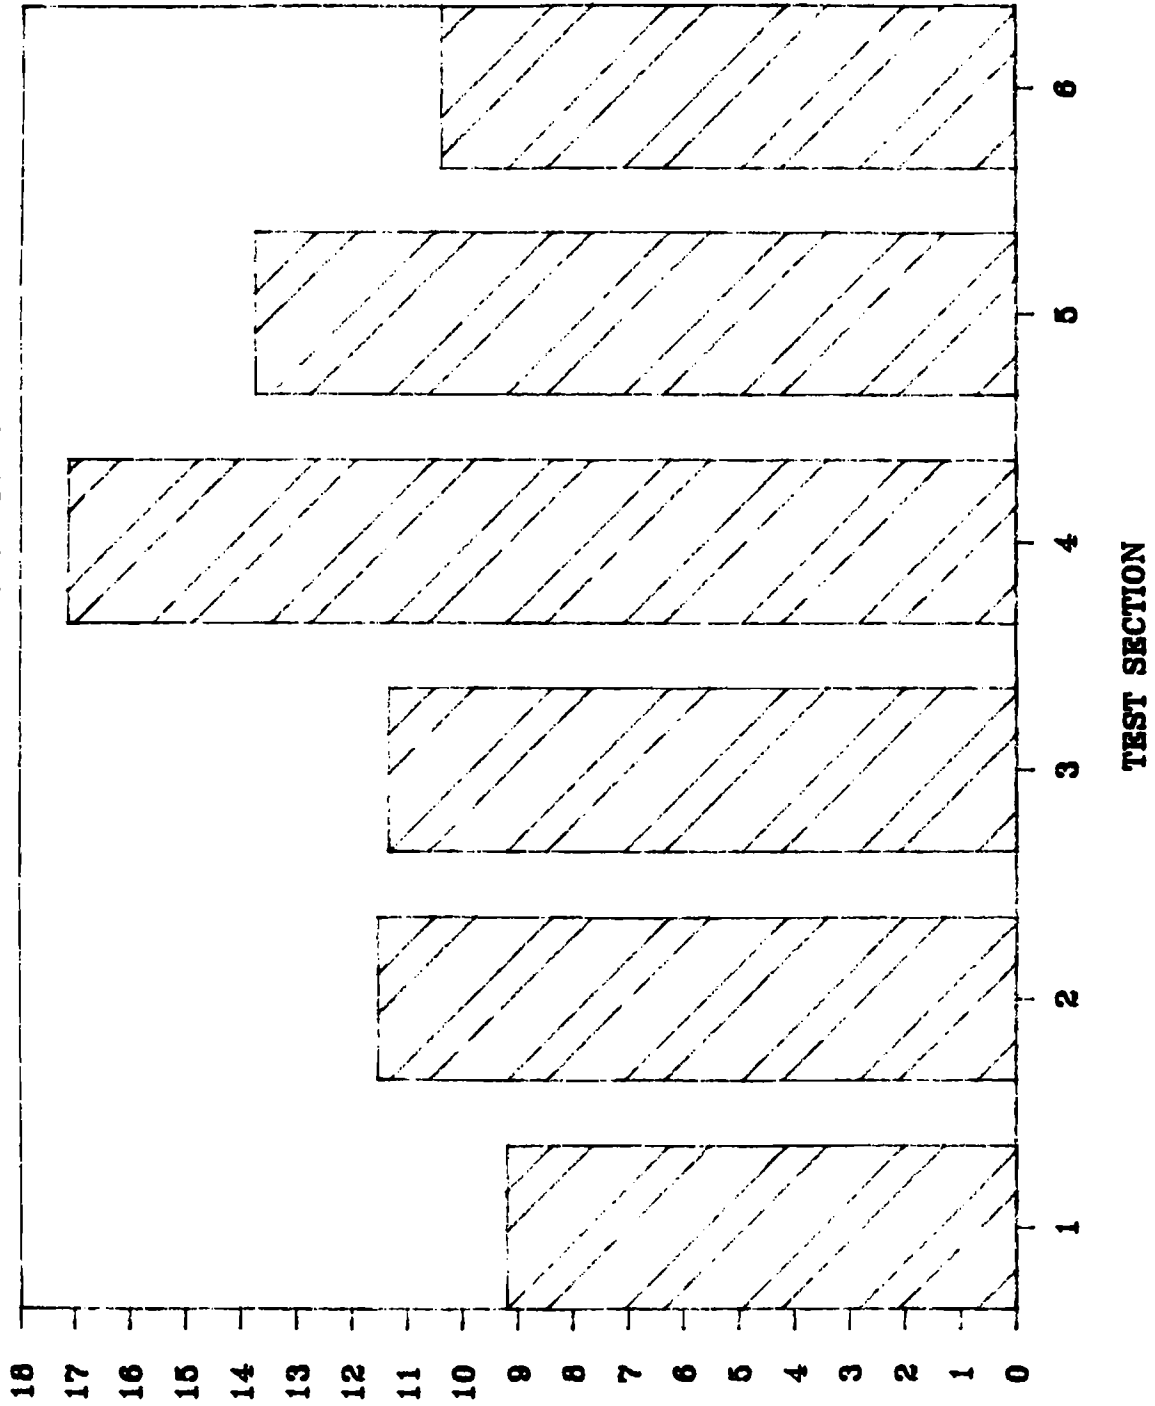
Figure 4. Maximum Seasonal Variations in Soil Moisture Content from July, 1978 to March, 1980, for Test Sections 1 - 6.

Another anticipated benefit of geotextiles, that of moisture transport in the subgrade, could be assessed by the soil moisture measurements and the pore water pressure readings. Although the soil moisture measurements were not consistent between the different measurement methods, there was still enough evidence to conclude that there was no apparent subgrade moisture transport in the fabric sections as compared to the control section. The maximum seasonal variation of subgrade moisture content in Section 5 was not significantly greater than that of the average of all of the fabric sections (see Figure 4).

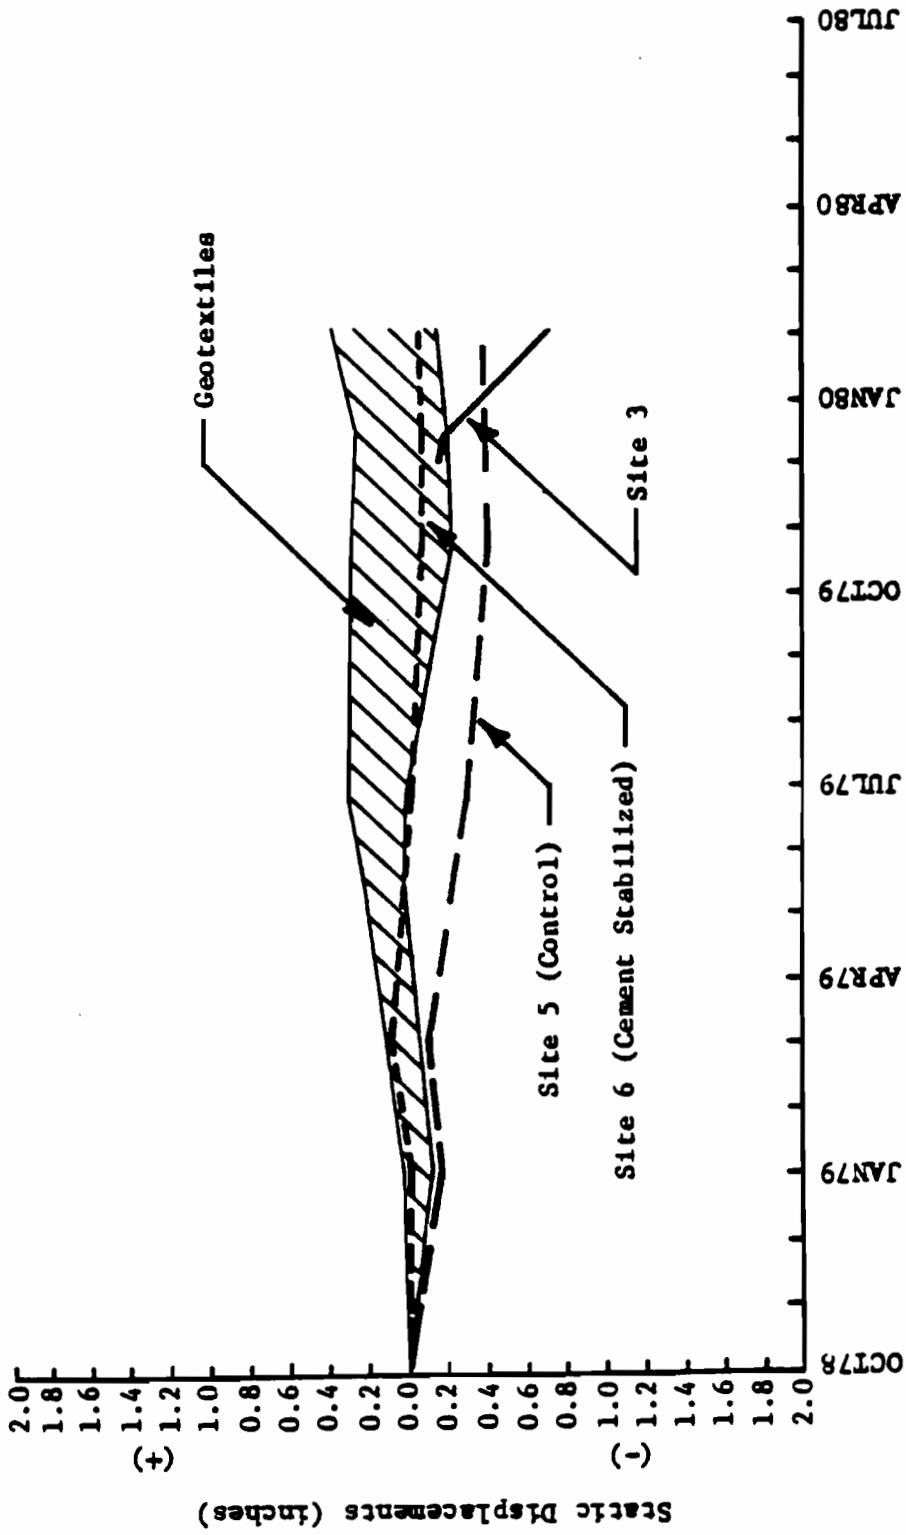
Figure 5. Extensometer Data Showing Static Soil Swelling and Settlement at Test Sections 1 - 6.

consistent trend in the rise and fall of the interface. Section 5, the control section, clearly experienced greater vertical settlements than the remaining sections. Note also that vertical movement of Section 3 began to accelerate rapidly during December, 1979. The failure of Section 3 occurred in January, 1980, as noted in Figure 5.

The control section did experience somewhat more ballast/soil interface settlement than the other sections (Figure 5). However, this is most likely due to ballast penetration into the subgrade in Section 5. Therefore, rather than a reinforcement function, the decreased settlement is probably attributable to the separation function of geotextiles.

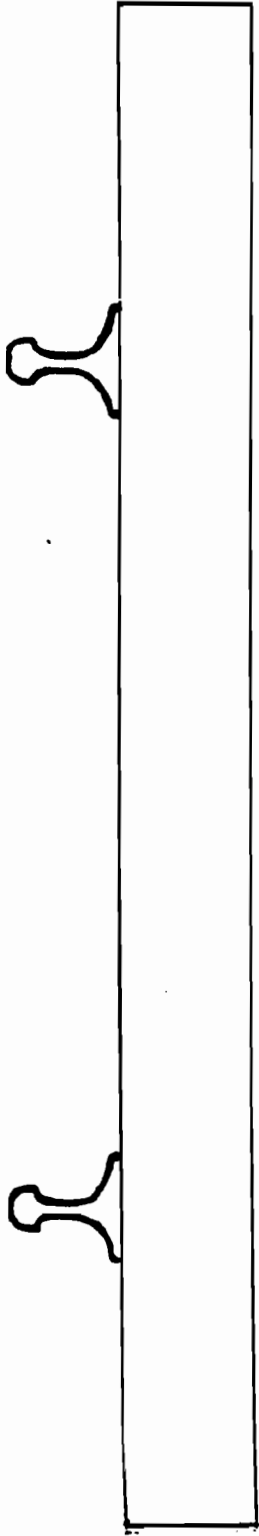
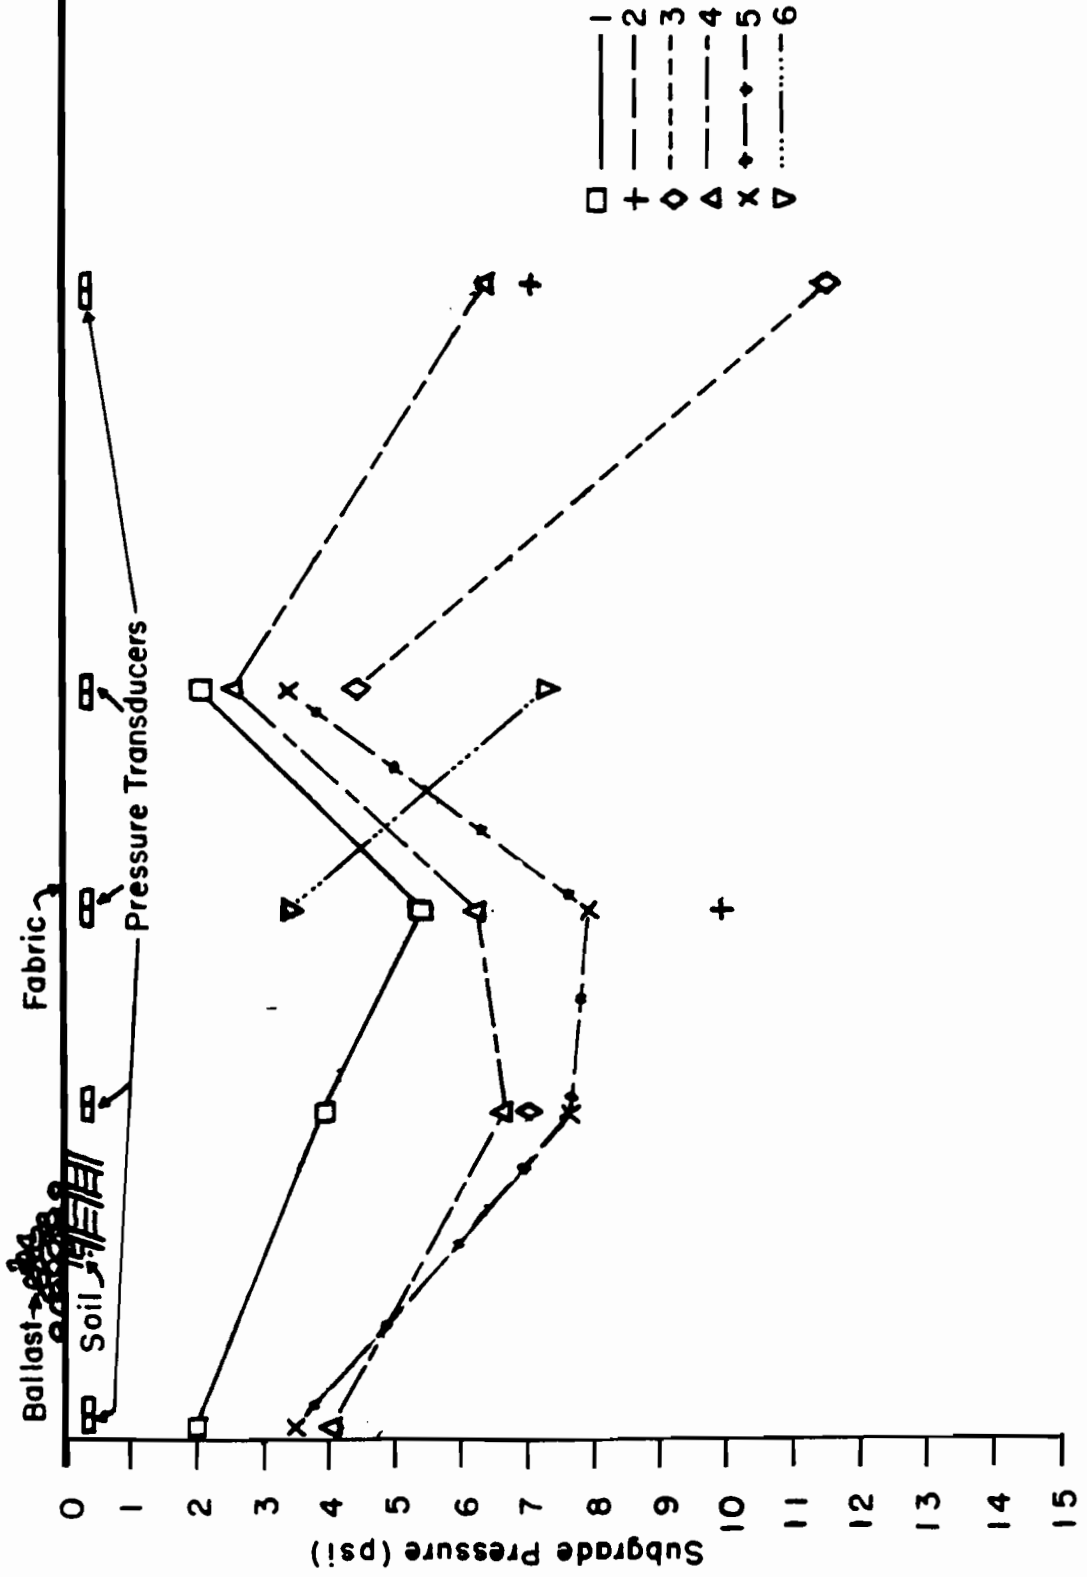
Figure 6. Subgrade Pressures Under One Tie in Each of Test Sections 1 - 6.

The transverse and longitudinal earth pressure measurements showed approximately the same pressure profiles for each site. No significant differences could be observed between the pressure profiles observed in the fabric sections and those in the control section. It is interesting to note that the maximum subgrade pressures were measured beneath the cement-stabilized section.

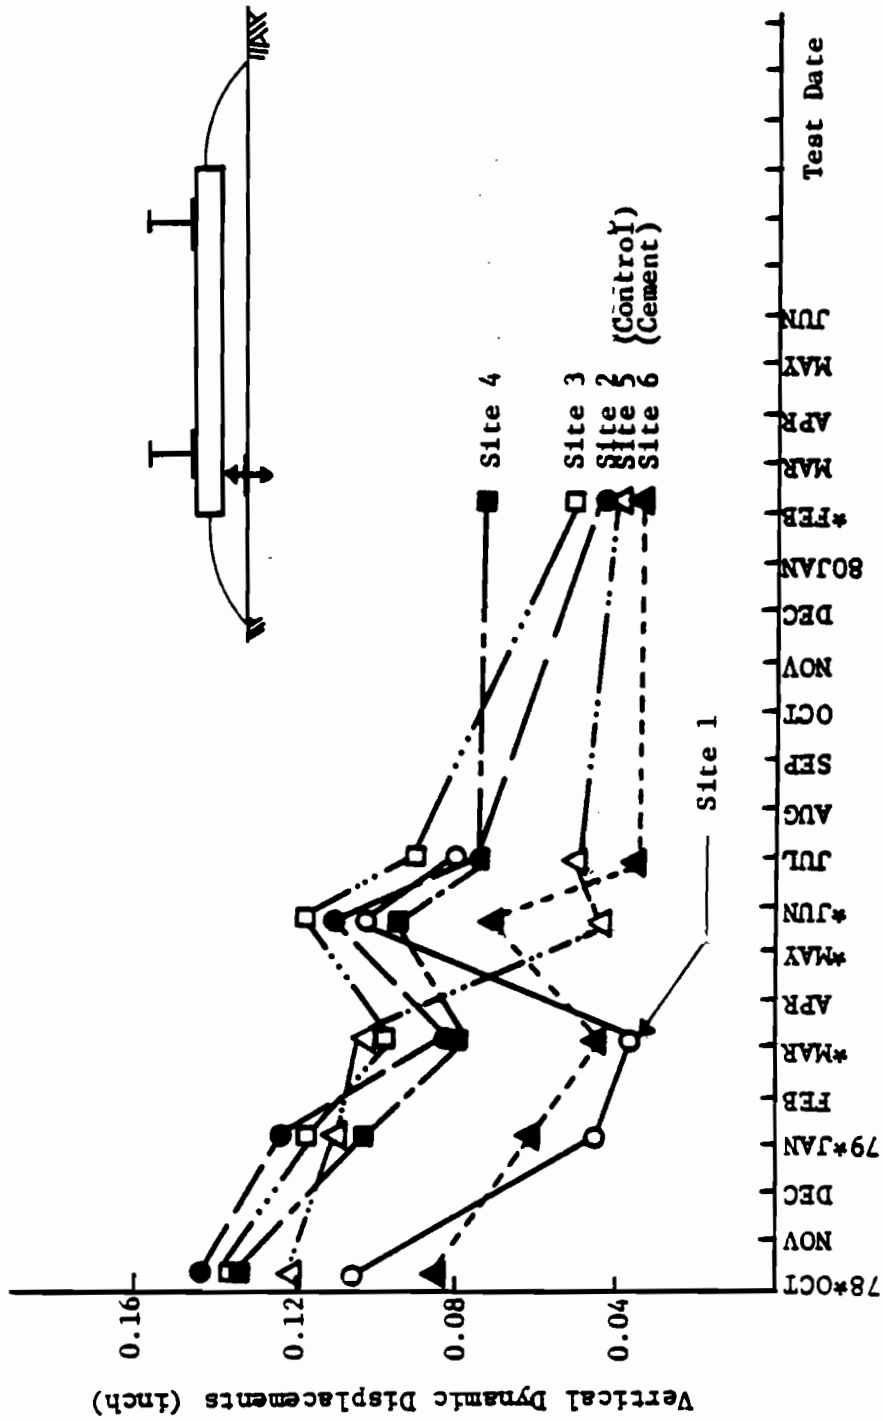
Figure 8. Variations in Mean Values of Elastic Deformation Under Load at the Ballast/Subgrade Interface With Time, for Test sections 1 - 6.

under loading are plotted in Figure 8 for the respective test dates. The elastic deformations measured in Sections 2, 3, 4, and 6 showed the same climatic variations, with Section 6 having consistently smaller amplitudes. General weather data obtained from Caldwell, Texas showed that March through June were months which had significant amounts of rainfall.

The anomalous behavior of Section 5 during the wet season was shown by decreasing elastic deformation, while the other sections were experiencing increasing deformations. Section 1 also had anomalous behavior, as evidenced by the wide range in deformation with the seasons. The soil moisture content data did not indicate that the soil in Section 1 experienced greater variation in of moisture content; in fact, the moisture content in Section 1 was the most uniform during this period.

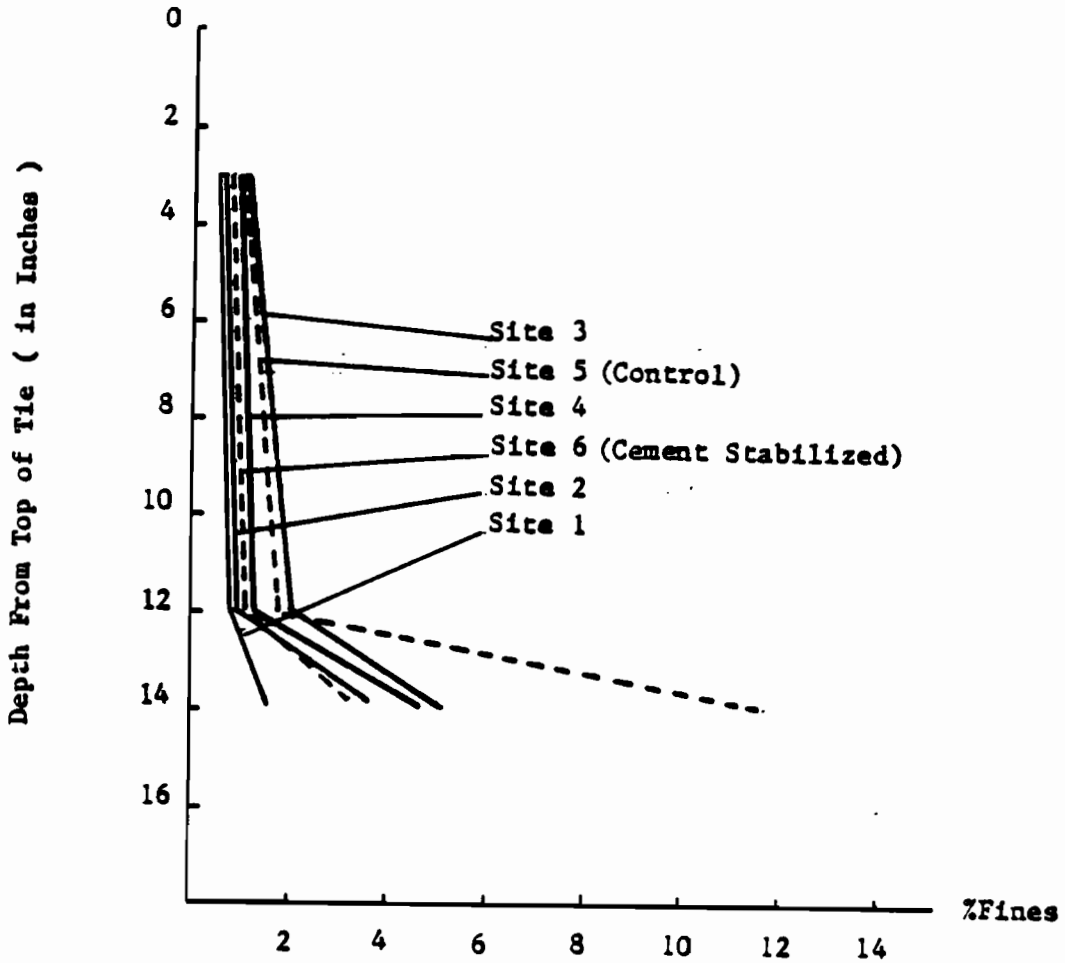
Figure 9. Percentage of Fines Passing a #200 Sieve Versus Sampling Depth in Test Sections 1 - 6.

Mean values were established for the percentage of contamination versus depth data from each test section, and are presented in Figure 9. In the upper 12 inches of ballast, only Sections 3 and 5 had contamination in excess of that measured in Section 6 (the "control" section). Note the contamination of the ballast just above the fabric: Section 5, with no fabric, had significantly more contamination than the remaining sections, and only Sections 3 and 4 of the fabric sections had significantly greater contamination than Section 6.

this indicates that large quantities of subgrade silts in addition to the clay, were moving into the section 5 ballast because no fabric was present. This substantiates the filtering capabilities of the fabrics with respect to silt-sized particles.

The quantities of clay-sized particles present within the ballast in Fabric Sections 1, 2, and 4 were between 2 and 3 percent by weight. Fabric Section 3 and Control Section 5 had about 8 percent clay fines near the bottom of the ballast layer. [In Fabric Section 3 this may be explained by the extrusion of the soil-slurry that had by then built up just under the fabric.] Percentages less than 4% or 5% are normally considered to be negligible, in that they will not influence the ballast performance. However, the amount of clay in Sections 3 and 5 may contribute to a degradation of the engineering properties of the ballast. An example of such degradation is the possible increased lateral spreading of the bottom layer of ballast under the lateral shear forces caused by traffic. Excessive track settlement can result.

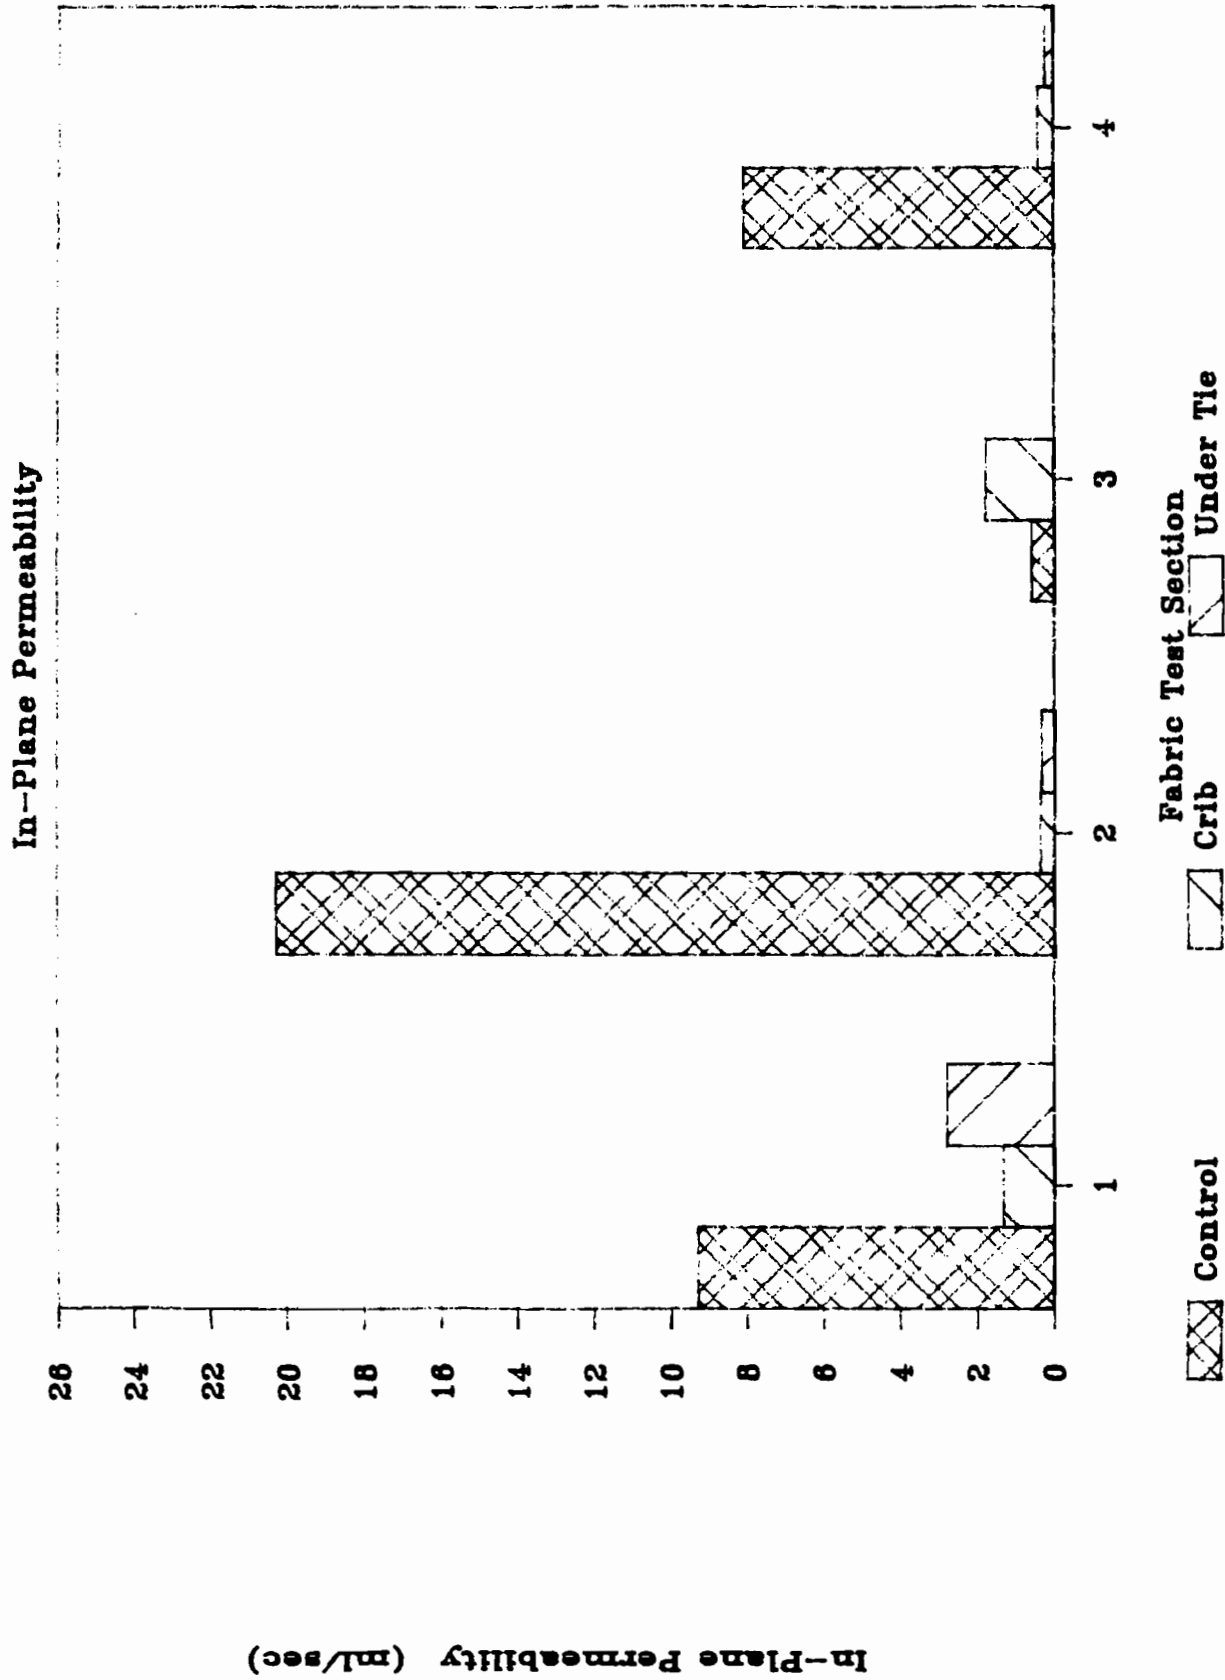
Figure 10. In-Plane Permeability of Geotextiles Recovered From the Field and Tested at a Pressure of 3.4 psi Applied Normal to the Surface.

Figure 10 illustrates the measured decrease in fabric permeabilities when tested in the soiled condition after removal from the field. As shown, the in-plane permeability of the fabric samples after 17 months in track have decreased by as much as a factor of 100. The fabric in Section 1 retained the greatest percentage of its initial in-plane permeability. The test performed on the fabric from Section 3 appeared to show a gain in permeability in the field, however, this test was reported by the technician to be in error. The fabric in Section 3 is known to have clogged more severely in the field than any of the other fabrics.

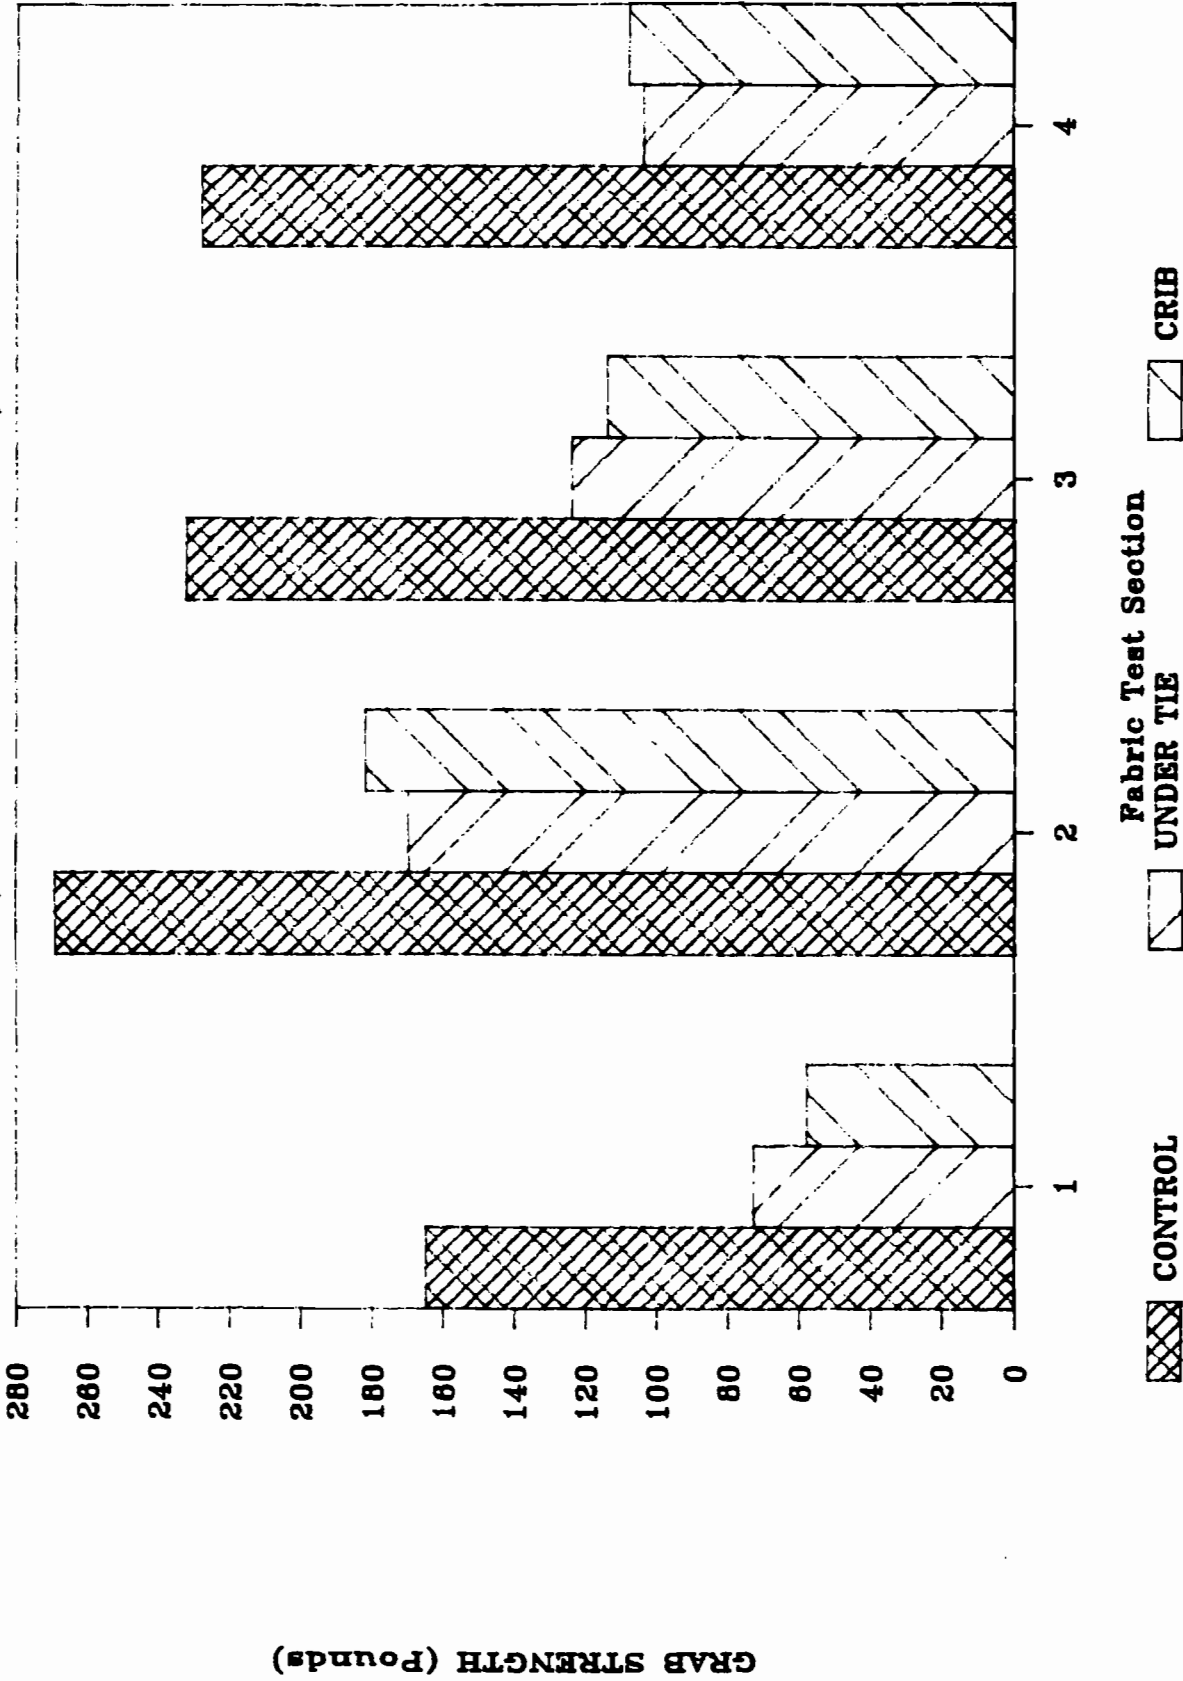
Figure 11. Grab Strength of Geotextiles Recovered From the Field and Tested Under Wet and Soiled Conditions

The grab strength test was used to determine the tensile resistance to tearing, when subjected to a slowly increasing load applied to either end of a standard size strip. Fabric in a soiled and wet condition was tested in this manner; the results are shown in Figure 11 for samples recovered from under the tie and in the crib area. The fabric with the largest loss of strength, as compared to the control, was Fabric 1, which exhibited a 56% decrease. Fabric 2 had the least amount of strength loss, with only a 35% decrease. A visual inspection at the time of fabric sampling from the field revealed that Fabrics 3 and 4 had the most holes from tamper and traffic-induced ballast puncturing. Also, despite the relatively low amount of retained grab strength, Fabric 1 was observed in track to have the least number of puncture holes.
