## **Bolted steel tanks, HDPE geomembrane linings**

*By Gregory N. Richardson*

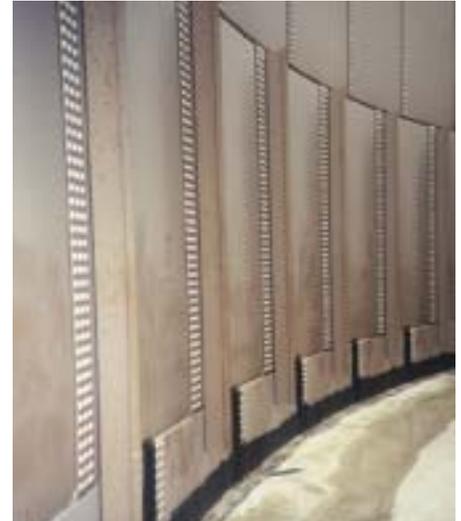
All tanks have bolted steel floors, but are installed in secondary containment tanks that have poured concrete floors and bolted steel walls. These secondary containment tanks have sumps that collected all leakage from the primary tank. Rain roofs are installed between the primary tanks and the secondary containment tanks to prevent rainwater from entering the detection system. Such secondary containment systems allow DCSWA to precisely monitor leachate leakage from the primary tanks. **Photo 1** shows the interior wall of the primary containment tanks; note the tank stiffeners and previous sealant application.

*Photo 1: Primary containment tank's interior wall with tank stiffeners and previous sealant applications.*

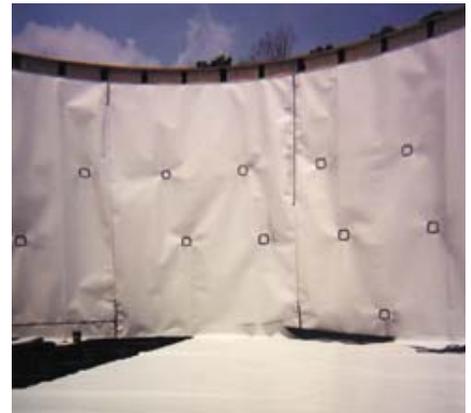
On the vertical walls of T802, only smooth bolt heads were exposed. This allowed the HDPE liner system to be placed directly against the steel plates. A batten strip bolted through the tank supports the top of the HDPE. Additionally, the HDPE is bolted to the steel side plates at less than 10-ft spacing, as shown in **Photo 2**. The bolts attaching the HDPE to the steel side walls are both provided with plastic washers and cap-stripped to eliminate possible leakage.

*Photo 2: HDPE bolted to steel side plates. Attaching bolts have plastic washers and are cap-stripped to eliminate leakage.*

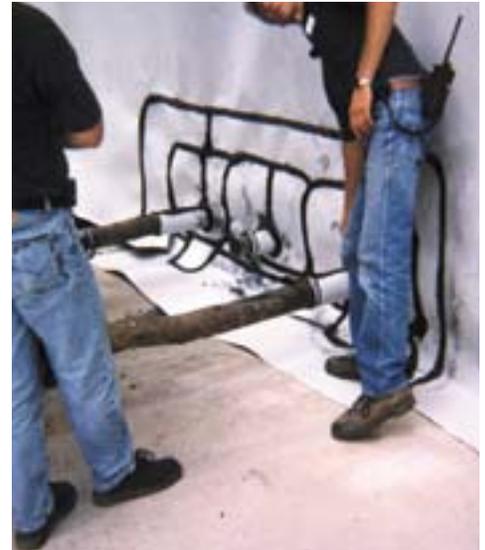
Pipe penetrations proved to be particularly difficult, because pipes serving T801 must penetrate three lining systems: T802 liner on the interior walls, T802 liner on the exterior of T801, and the interior T801 liner. Pipes entering T801 would require three boots. The pipes serving T802 penetrated only the liner system placed on the interior of T802. Initially, all pipe penetrations were made using conventional field-fabricated boots. In order to install boots for pipes T801, the boots had to be split, therefore requiring an additional seam in the pipe direction as shown in **Photo 3**.

**Photo 3:** Split boots for tank T801, showing the additional seam required for the installation.

Concern immediately focused on the boot connections securing all of the pipe penetrations, particularly those

that were placed over the Ethafoam on tank T801. The pipes going to the small interior tank were replaced with HDPE pipes using an HDPE/steel transition fitting. This allowed elimination of the longitudinal boot seam and direct welding of the boot to the pipe. With this change made, the HDPE liner passed the confidence test.
