Active LFG Control: An Unreliable Aid to Veneer Stability

Gregory N. Richardson, Ph.D., P.E.
Stacey A. Smith, P.E.
Pieter K. Scheer, P.E.

Presented by:
Pieter K. Scheer, P.E.

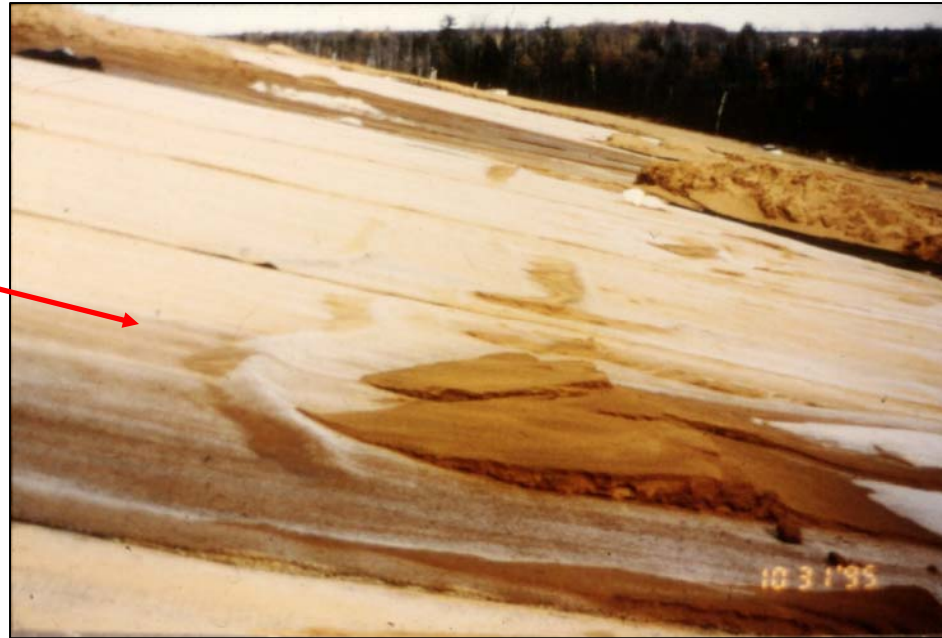
Exposed
GCL

Final Cover System on 4H:1V slope with components (top-down):

- 1.5-ft topsoil and vegetative soil;
- 1-ft sand drainage layer;
- PVC geomembrane;
- GCL having nonwoven side down, slit film side up;
- 1-ft thick LFG relief layer of fine sand; and
- Interim cover/structural layer immediately over waste.

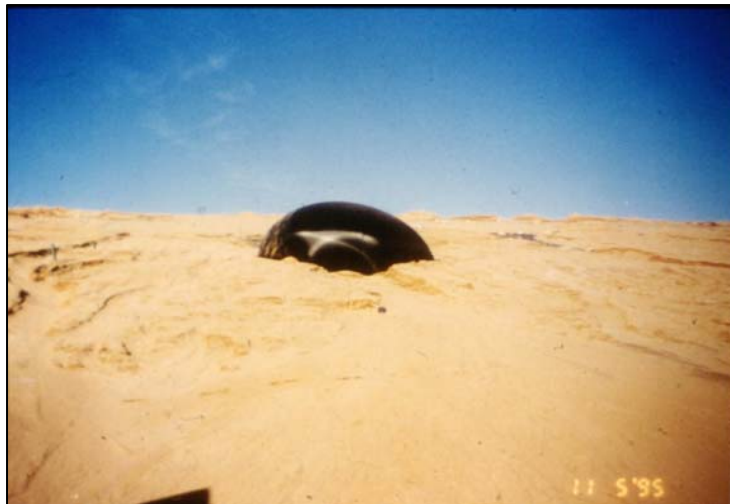
- Failure occurred along PVC geomembrane/GCL interface before placement of final 1.5-ft of soil.
- PVC GM/GCL interface ($\phi = 16$ degrees; $a = 11$ psf) (not very robust) theoretically stable ($FS > 1.0$) at < 10 inch- H_2O LFG pressure.
- Average LFG pressure of 6.6 inch- H_2O and a maximum LFG pressure of 16 inch- H_2O were measured after failure.

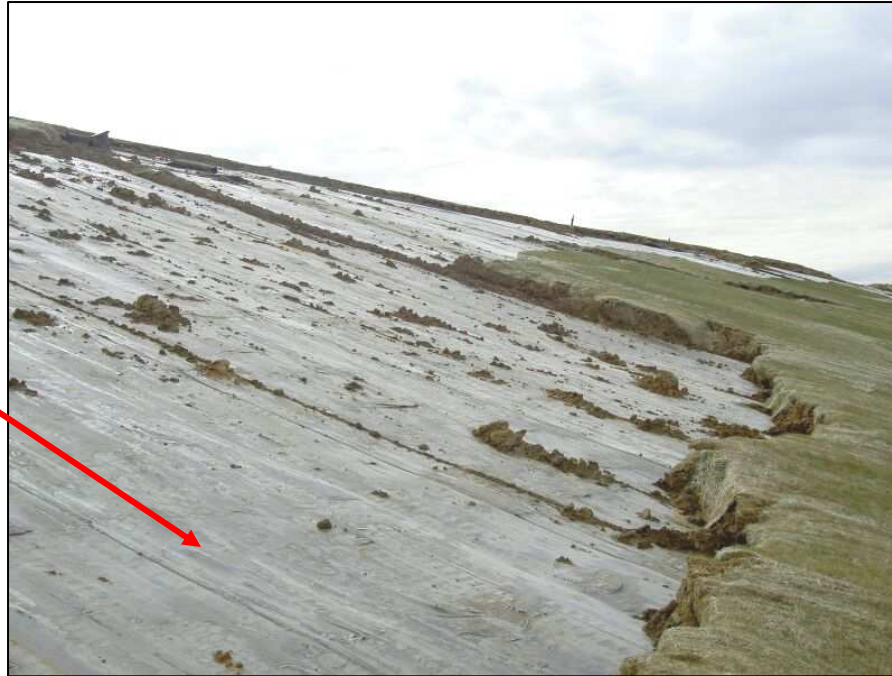
Exposed
GCL

Final Cover System on 3H:1V slope with components (top-down):

- 2-ft topsoil and vegetative soil;
- 8 oz/sy nonwoven geotextile
- Text. LLDPE geomembrane (spikes on bottom/drain surface on top);
- GCL having nonwoven side down, woven side up; and
- 1-ft interim soil cover immediately over waste.

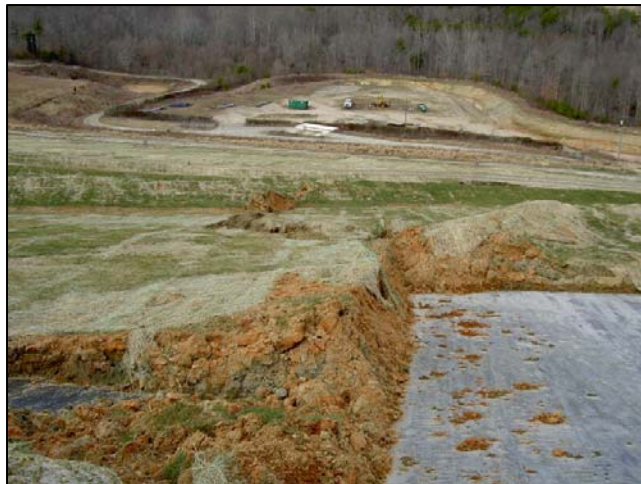
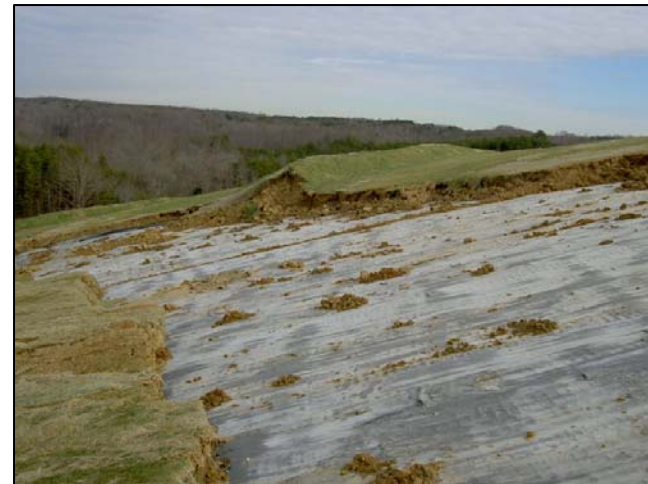
- Failure occurred along LLDPE geomembrane/GCL within a few months of completion of the final cover system. The LLDPE geomembrane used was a structured product with conical spikes on the bottom and a studded drain layer (in conjunction with the nonwoven geotextile) on top.
- At the time of discovery of the failure, the active gas recovery system had been down for about one week for maintenance.

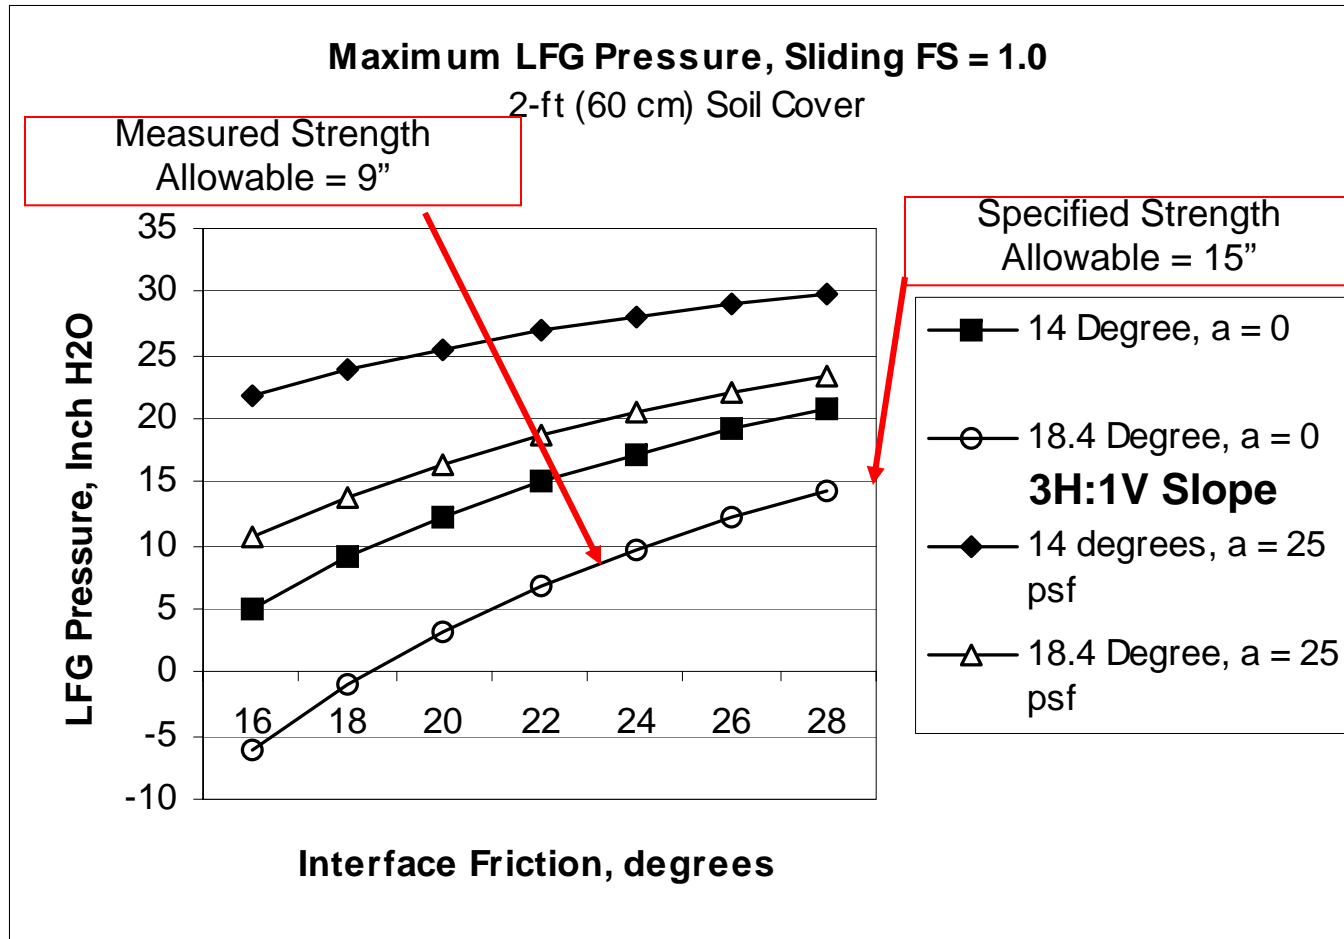
- Pre-construction testing of LLDPE GM/GCL interface ($\phi = 29$ degrees; $a = 0$ psf) theoretically stable ($FS > 1.0$) at < 15 inch- H_2O LFG pressure.
- Post-failure testing of LLDPE GM/GCL interface ($\phi = 23.5$ degrees; $a = 0$ psf) theoretically stable ($FS > 1.0$) at < 9 inch- H_2O LFG pressure.
- The significantly lower interface shear strength was attributed to dragging of the geomembrane downslope during deployment. The dragging reduced the asperity height of the spikes (i.e. dulled the tip of the spike).

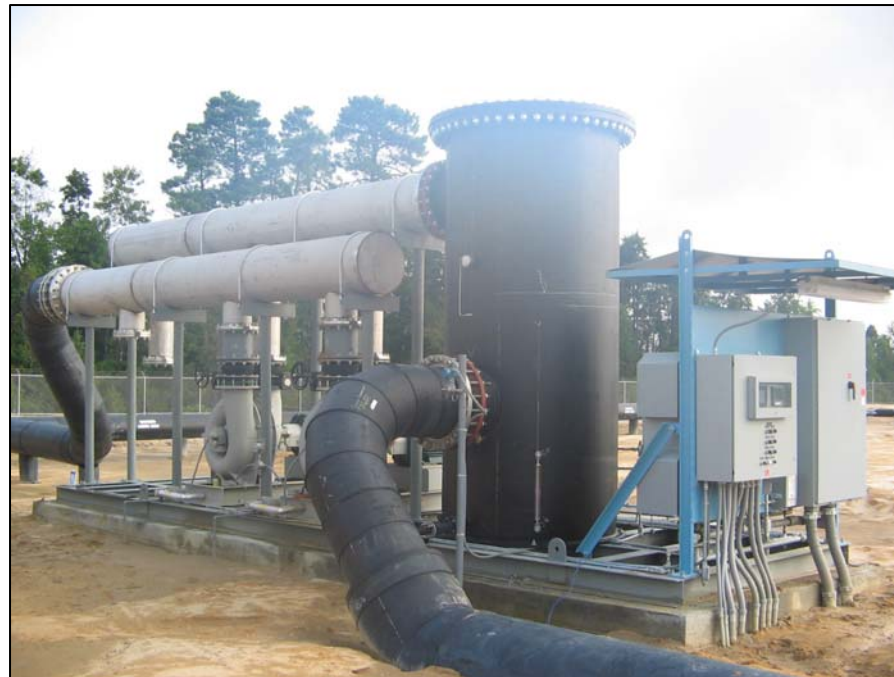
- To evaluate the effect of the active LFG system shutdown, a single recovery well was removed from an active LFG system and the subsequent increase in LFG observed.
- From an initial vacuum of 9-inch H₂O, it took only one hour to achieve a zero pressure. Over the next five (5) hours, the LFG pressure increased to 1.5-inch.
- Thus, **over a 10-inch increase in LFG pressure required less than six (6) hours.** This increase occurred despite the presence of adjacent LFG wells that remained in service and under the full operational vacuum.

- Conservative design would assume that **full LFG pressures would develop in less than two (2) days** if the entire active LFG system shuts down.
