Designer's Forum- Beneath the bubble: industrial lagoon closure

By Gregory N. Richardson, Ph.D. P.E., Stacey A. Smith, P.E., and Timothy F. Carr, L.E.P.

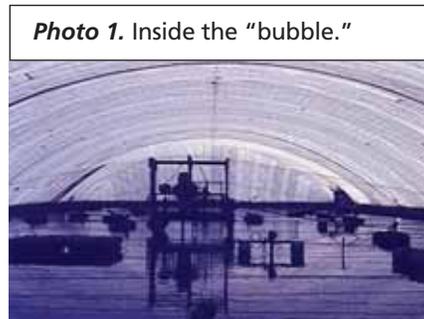
Photo 1. Inside the "bubble."

This 1.5 acre sludge lagoon was the last step in the wastewater treatment process. Historically, the facility effluent was chemically treated to flocculate out solids in the lagoon. Several decades of operations had left a significant volume of sludge within the lagoon. The wastewater was also aerated by two large pile-supported aerators mounted within the lagoon and a number of small floating aerators to remove volatile wastes. As a result of this aeration, the lagoon had been covered by the "bubble" to contain odors as shown in **Photo 1**.

The client required that this bubble remain in place until the sludge was contained by an equally effective means of controlling the odor. This meant that a portion of the closure work would have to take place beneath the bubble. The presence of the bubble limited equipment access to the lagoon and meant that all construction materials had to pass through air portals.

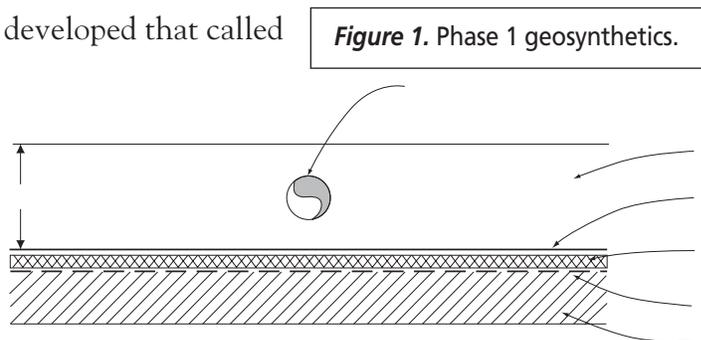
Figure 1. Phase 1 geosynthetics.

A 36-mil metallocene (mPE) geomembrane provided isolation of the sludge. A drainage composite and high strength woven polypropylene reinforcement fabric are below the geomembrane: the drainage composite to collect consolidation water coming from the sludge, and the high strength woven reinforcement to aid in load distribution.

The initial and most difficult phase of closure had the dual goals of containment of the sludge related to air emissions and the initial consolidation of the sludge itself. All of the Phase 1 work was performed under the bubble. **Figure 1** shows the geosynthetic components that were key to the success of Phase 1.

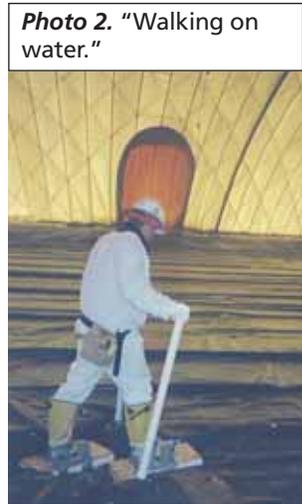
Photo 2 shows the completed geosynthetic system in place beneath the bubble. This photo is generally referred to as “walking on water.” Each layer was fabricated outside of the bubble, rolled up and passed through a modified airlock portal and then unrolled for final deployment.

Photo 2. “Walking on water.”

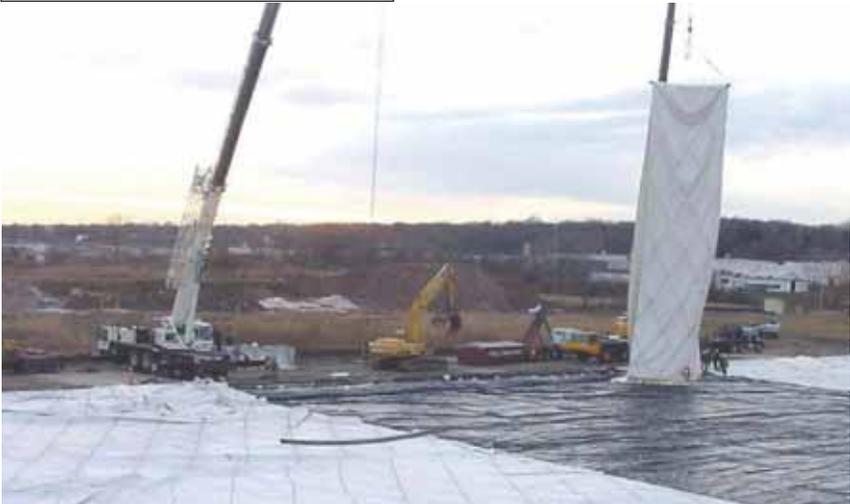
The rate that water could be removed from beneath the geomembrane was limited by the capacity of a newly constructed wastewater treatment facility to receive it. Initial loading of the geomembrane was accomplished using only clean water to surcharge the geomembrane. While producing only a limited increase in the strength of the underlying sludge, completion of this phase allowed removal of the bubble shown in **Photo 3**. Prior to removal of the bubble, Styrofoam sheets were floated over the pond to further protect the geomembrane from potential damage from the steel cabling used to secure the bubble. Bringing the bubble down took less than 10 uneventful minutes due to these precautions

Photo 3. Removal of the bubble.

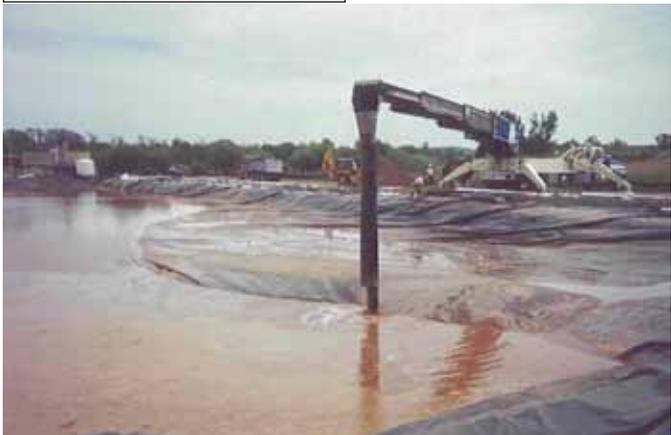
The revised soil placement technique centered around a unique conveyor truck originally designed for placement of rip-rap. As shown in **Photo 4**, the conveyor truck (Telebelt) allowed pinpoint placement of soil without the need for equipment directly on the geosynthetics. The Telebelt could place up to 1500 cubic yards of fill in an eight hour shift and enabled all bulges to be loaded and flattened. The rate of fill placement was limited by the rate of treatment of the new wastewater plant and not the Telebelt. The Telebelt was used to place approximately 5 ft. of cover over the geosynthetics. After this placement, conventional means could again be used to place the fill.

Photo 4. Placement of soil.

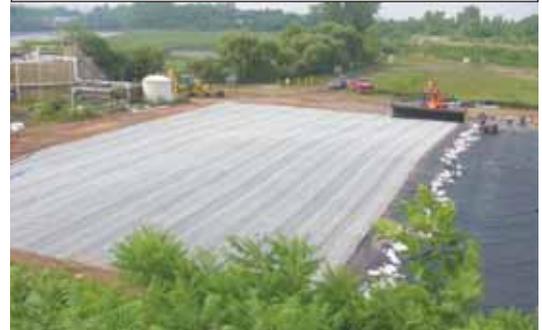
Photo 5 shows the construction of the final cover moving west to east. The soil was graded to provide a typical slope of 3% to the perimeter. **Photo 6** shows the completed final cover over the lagoon.

Photo 5. Geomembrane installation.

Once the majority of primary consolidation was finished in the sludge, the fill was regraded to final cover contours. The RCRA final cover consisted of the following from bottom up:

- reinforced geosynthetic clay liner (GCL)
- 60-mil HDPE geomembrane
- geosynthetic drainage composite
- 28-in. of sandy vegetative support soil
- 6-in. of topsoil with grass cover.

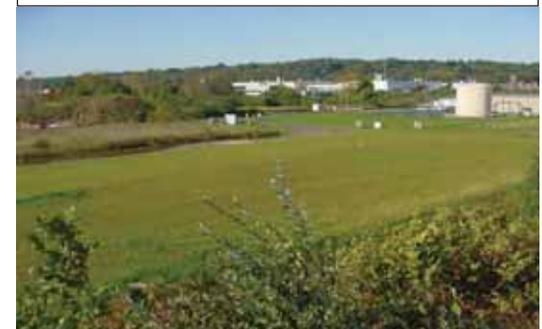
Photo 6. Completed final cover.
