# Lessons Learned From the Failure of Geotextile Erosion Control Tubes

by G.N. Richardson

**ABSTRACT:** Large circumference sand fill geotextile tubes were used to stabilize the beach on a small private island facing the Atlantic. The tubes were stacked to provide a low profile erosion resistant barrier to shoreline erosion. The geotextile tubes were used in place of concrete or sheet pile revetments because of a State law that limited the use of 'hardened' structures on the coastline. This paper reviews two design concepts for the tube erosion barrier system and chronicles the installation of a regulatory driven compromise system. Additionally, the paper describes the eventual failure of the regulatory system and makes observations regarding the performance of such systems.

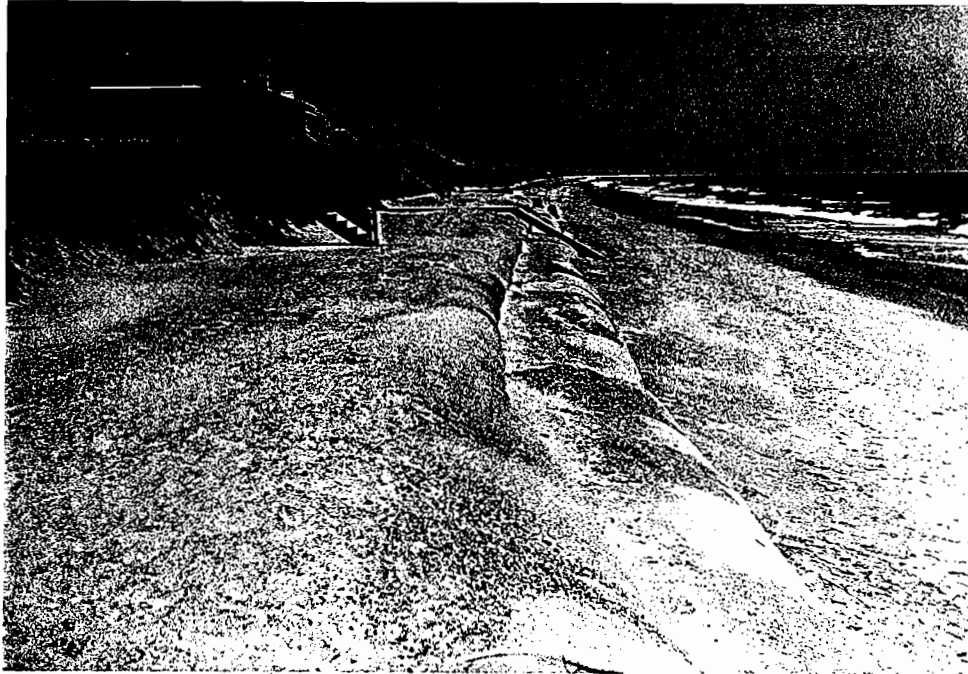
Figure 7 Completed Shoreline Erosion Control Tube System

The system of erosion tubes was installed on the beach during the summer of 1988. Each tube was filled with sand by placing the discharge pipe of an 8 inch cutterhead dredge through one of the fill ports provided every 100 feet in each tube. Figure 6 shows a tube being filled with sand in this manner. Note the dramatic discharge of dredge water through the tube. As the sand approached the fill port, the pipe was withdrawn and inserted into the next fill port. Movement of the pipe required a tracked backhoe, but the marine contractor soon became very adept at filling the bags. Approximately 1 bag could be filled each 8-hour day. Once the full system of tubes was placed, the marine contractor placed additional dredged sand behind the tube system. Figure 7 shows the final system in place and awaiting the fall Northeasters. Actual placement of the tubes when essentially as planned.
